Maintenance Actions to Address Fatigue Cracking in Steel Bridge Structures

PROPOSED GUIDELINES AND COMMENTARY

NCHRP Transportation Research Board of
The National Academies

Robert J. Connor and Jason B. Lloyd
Purdue University
West Lafayette, Indiana

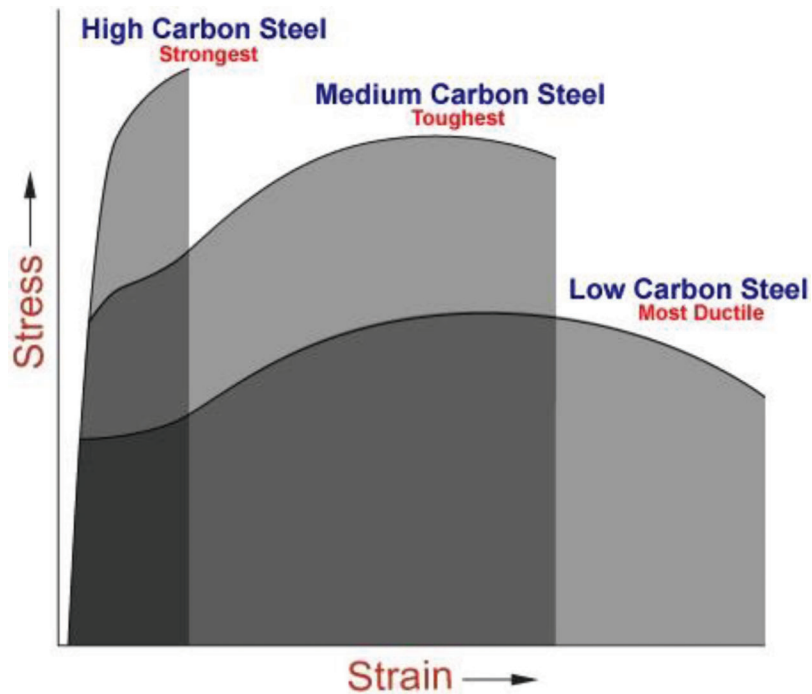
Figure 3.2. Material toughness curves (NDT Resource Center, 2014).

In simplest terms, crack propagation is a release of stored strain energy. If the release of the energy exceeds the ability of a material to absorb energy, then the crack will continue to grow. Toughness is the material property that quantifies the ability of a material to absorb energy, or resist fracture. The amount of energy that can be absorbed relates to the local plastic deformation at the crack tip prior to fracture initiation and throughout fracture propagation. This can be graphically represented by the area under the stress-strain curve. Figure 3.2 qualitatively illustrates this concept with three different types of steel. The first, High Carbon Steel, possesses high strength and low ductility and the lowest toughness. The Low Carbon Steel possesses a lesser strength, higher ductility and a higher toughness than the High Carbon Steel. The final example is the Medium Carbon Steel that fall between the previous types, possessing a compromise of ductility and strength while having the highest level of toughness. In this example, the High Carbon Steel would be expected to behave in a brittle manner. The Medium Carbon Steel better represents a typical High Performance Steel (HPS) where the optimal combination of

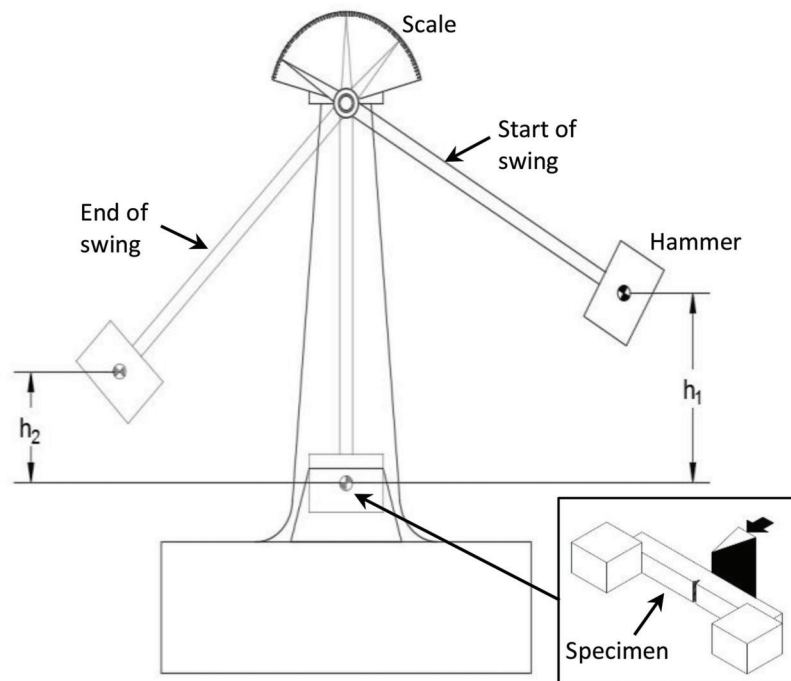
Figure 3.3 Charpy impact test machine.

CVN testing is a standardized high-strain rate impact test used to determine how much energy a small bar containing a machined notch can absorb before fracture occurs. This test is not a direct measurement of

During the test, a Charpy specimen is cooled to the desired temperature and maintained at that temperature for at least 5 minutes. Tongs, which are also cooled

and maintained at the test temperature, are used to extract the specimen from the cooling bath and place it in the test machine within a specified time limit, so as to minimize any warming of the specimen. Once the specimen is placed, a lever is pulled on the test machine and the hammer swings from a high position impacting the specimen opposite the notch, as shown in Figure 3.3. The energy absorbed by the specimen is measured by knowing the hammer weight, the height of the hammer in the start position (h_1) and the height at the end of the swing (h_2). The difference between these two potential energies is the energy absorbed by the specimen, which is indicated on the calibrated scale. Videos showing CVN Impact testing can be seen here: <https://doi.org/10.4231/R7H41PC8> and <https://doi.org/10.4231/R74T6G98>.

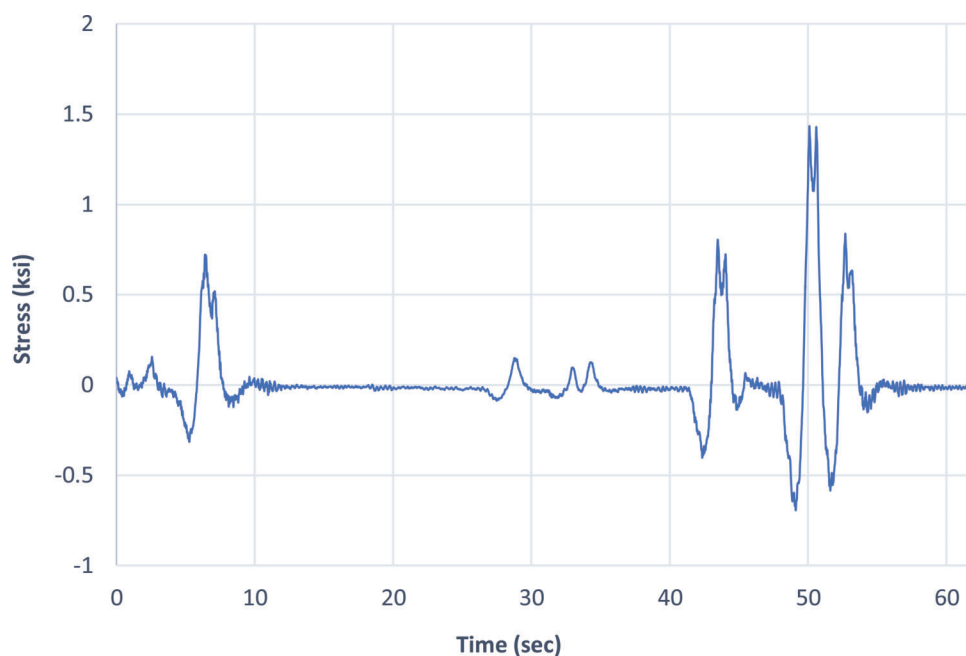
Figure 3.6 Sample variable amplitude load spectrum from field monitoring.

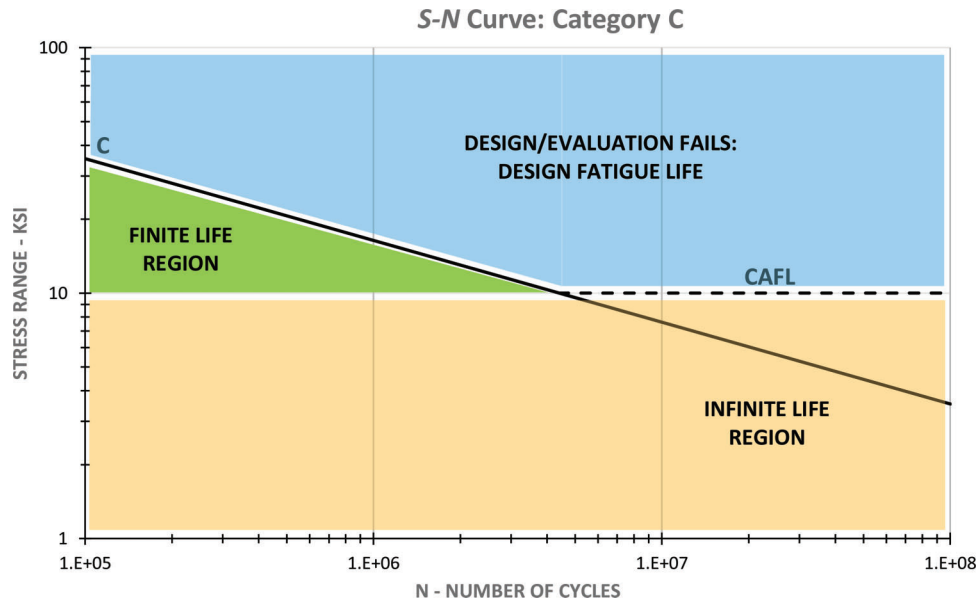
Figure 3.7 Category C *S-N* curve illustrating the regions of the plot.

Steel bridge details possessing similar fatigue resistance have been grouped into categories and assigned letters A through E'. There are eight categories in total, listed here in descending order of fatigue resistance: A, B, B', C', C, D, E, and E'. An AASHTO design curve, such as that seen in Figure 3.7, represents the fatigue resistance for each respective category. The sloped portion of the curve represents the number of cycles at a given stress range that can be expected for a detail before significant cracking will occur. The region of the plot below the sloped line is referred to as the

“finite life” region. The horizontal section of the curves are called the Constant Amplitude Fatigue Limits (CAFL) or Constant Amplitude Fatigue Thresholds (CAFT). These terms are synonymous and used interchangeably in the literature. If the maximum stress range is less than the CAFL for a given detail category, it can be expected that an infinite number of cycles can be resisted without incurring fatigue damage. The region of the curve below the CAFL is referred to as the “infinite life” region.

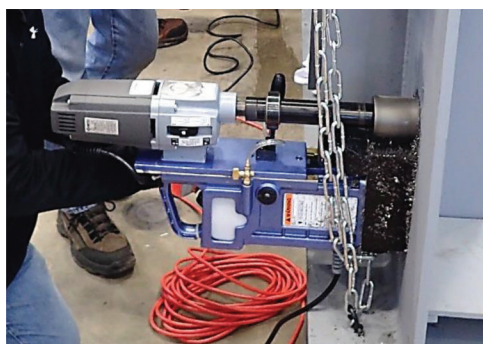
Figure 4.1 (Left) Example of magnetic-based drill, (Right) Annular cutter used for hole drilling.

The equipment recommended for hole drilling includes a magnetic-based drill and annular cutter, such as that seen in Figure 4.1. Although, hand drills have been shown to be effective, even for larger diameter holes, when operated by trained and experienced crews, magnetic-based drills offer superb control and precision for a wide range of hole sizes. The greatest challenge can be positioning the drill in tight spaces where intersecting elements of a detail leave little room for the drill to seat properly.

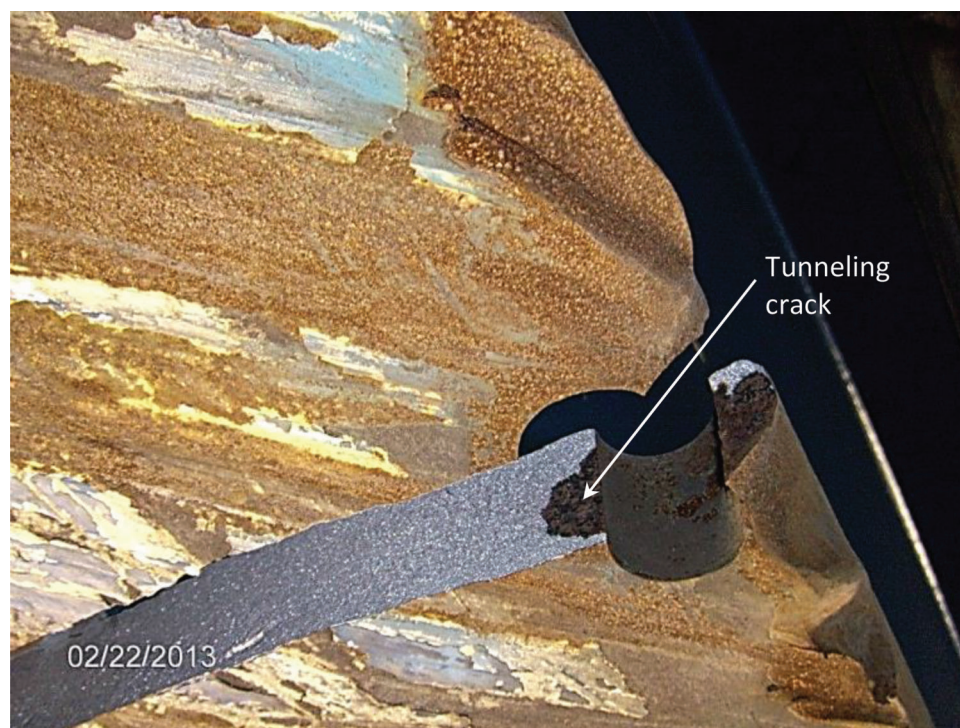
Figure 4.2 Crack tip tunneling contributing to a missed crack tip that later fractured.

Crack tunneling can also contribute to missed crack tips if the engineer or technician is unaware of this phenomenon. Crack tunneling is the term used to describe the preferential advance of the crack tip at the center of a plate with the edges lagging behind. Additional triaxial restraint through the thickness of the plate can promote slightly quicker growth rates with a hidden leading edge, particularly in thicker plates. An extreme example of crack tunneling is shown in Figure 4.2 where a drilled hole was installed to attempt to arrest a crack caused during an impact event. The corroded surface indicates the extent of the previous crack and the bright silver surface indicates the new fracture that propagated instantaneously during another impact event some months later. Notice that the previous crack tunneled ahead of where it breaks the surface of the plate. Furthermore, surface inspection methods

such as MT or PT could not have detected the leading crack tip toward the middle of the plate thickness; UT could have been used to detect it, however.

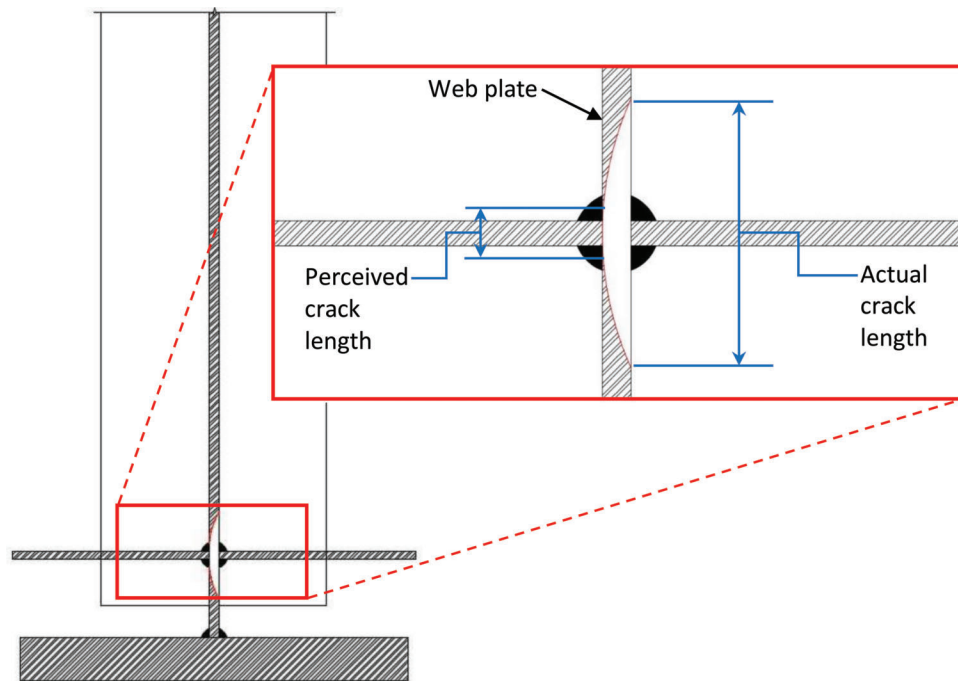
Figure 4.3 Crack length appears different on each side of a plate as it transitions to through-thickness.

A similar effect has been observed for penny-shaped fatigue cracks that will be one length on a given side of a plate and appear to be shorter on another as the crack transitions to a through-thickness crack. For this reason NDE should be performed on both sides of the cracked plate to ensure the longest dimension is characterized and the leading edge is arrested with the drilled hole. A sketch illustrating an extreme example of this concept is provided in Figure 4.3, which shows the cross section view of a typical interior plate girder with welded gusset plates. The hatched section indicates the uncracked section. Notice that if inspection only occurred on the left side of the web plate, the crack length would be severely mischaracterized and it would be possible that the crack tip would not be removed during hole drilling.

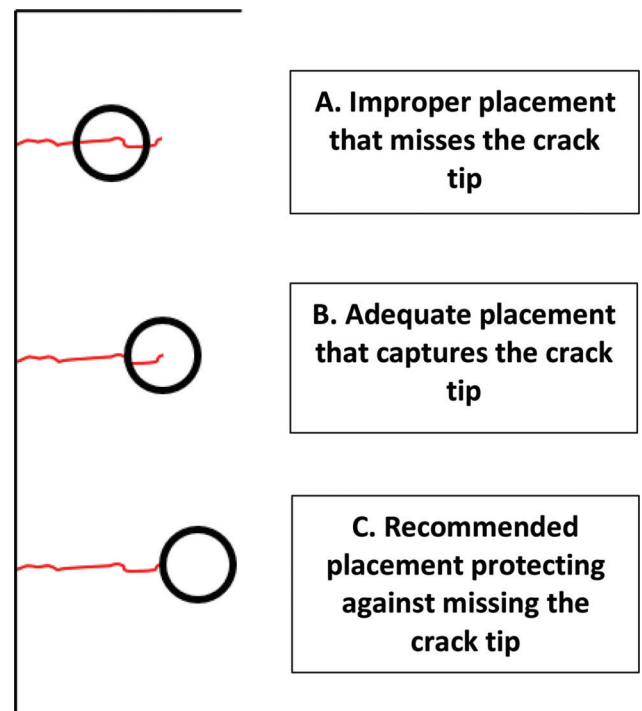
Figure 4.4 Improper and proper drilled hole placements for crack arrest.

Correct hole placement, relative to the crack tip, is one of the most important considerations for effectively drilled holes. Consider the examples of hole placement illustrated in Figure 4.4, as first proposed by Fisher *et al.* (1980). The top example, A, shows a case where the crack tip is entirely missed by the drilled hole and the crack tip is allowed to continue growing. The second, B, depicts an acceptably placed hole because it adequately captures the crack tip. The third scenario, C, is the recommended placement. The hole is drilled such that the edge of the annular cutter just intercepts the crack tip. This approach is recommended because it better safeguards against the possibility of missing the tip. Even if the hole is inadvertently drilled slightly ahead of the crack tip, the crack will only be able to grow until

it intercepts the hole and then will become arrested. However, it is not necessarily recommended that the hole be purposefully drilled away from the crack tip as if to anticipate arrest. All efforts should be made to locate the crack tip and place the cutter such that it intercepts the tip. Once the hole has been drilled, a couple of simple

- If the removed core splits in half, then the crack tip has been missed and the hole placement corresponds with scenario *A* in Figure 4.4. The crack tip should be relocated using MT or PT and then another hole drilled, or grinding should be performed to remove it.
- If the crack can be seen on one edge of the hole in the drilled plate, but not on the opposite side, then the tip has been adequately removed (see Figure 4.9). The crack may also appear on one side of the removed core, in which case the hole placement corresponds with scenario *B* in Figure 4.4.
- If the crack can be observed on one edge of the drilled plate, but not on the opposite side, and also cannot be observed anywhere in the removed core, then the hole placement corresponds with scenario *C* in Figure 4.4.

2. Position the magnetic-based drill as seen in scenario C of Figure 4.4. *Caution: Tie off the mag-based drill to the girder using sturdy clamps and chainrope in the event of power loss. This will help prevent injury or damage to equipment.*

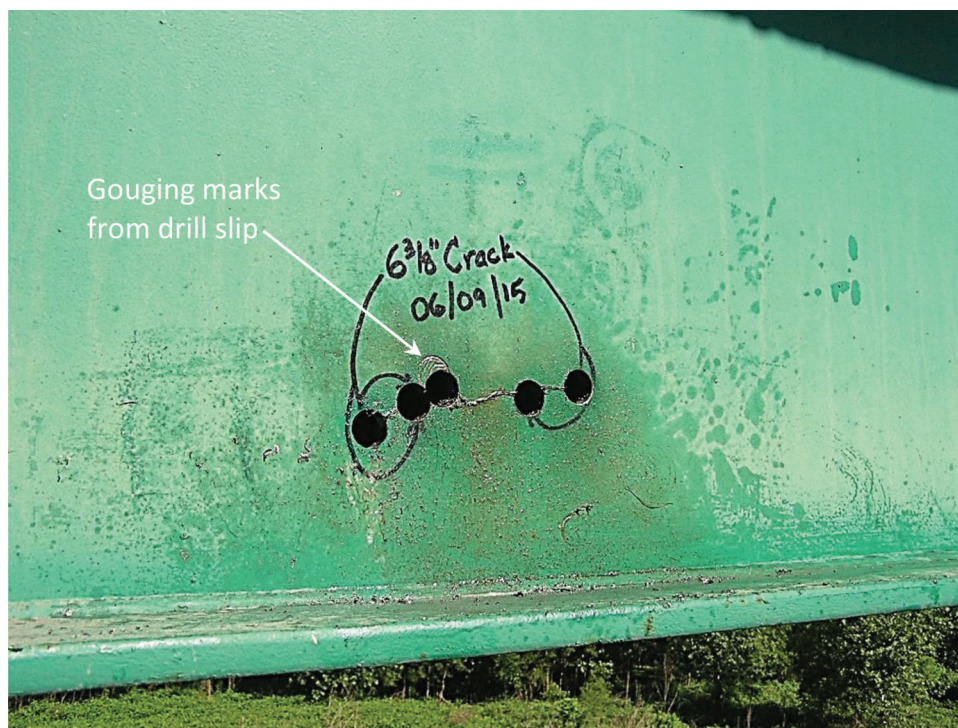
Figure 4.5 Example of chasing the crack tip with repeated drilling.

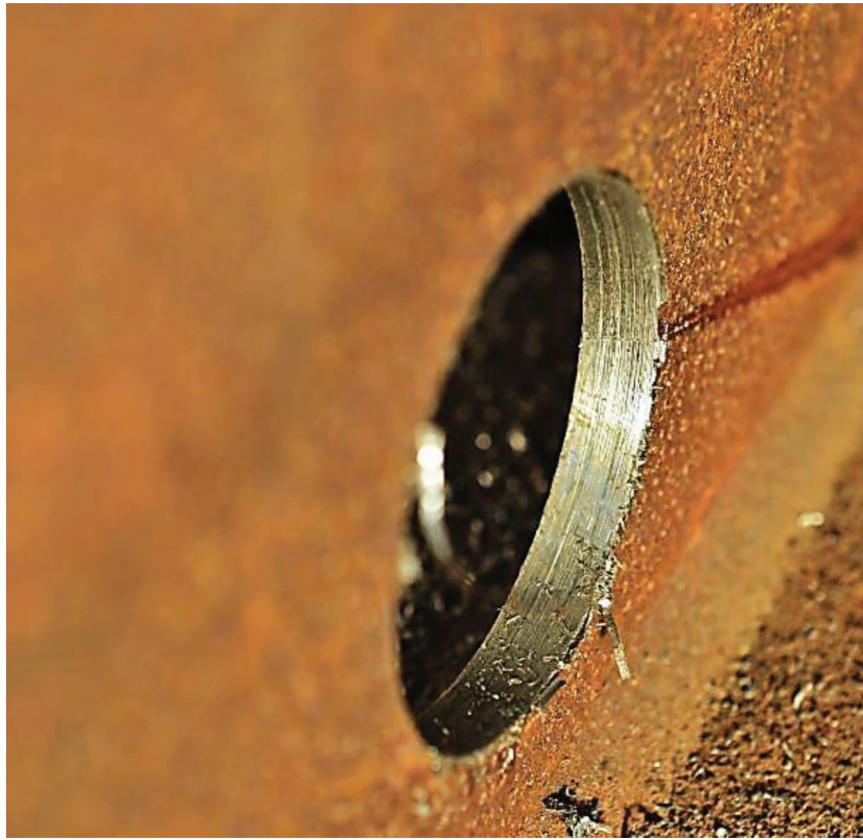
Figure 4.6 Drilled hole showing rough edges and burrs.

Another important consideration is the edge condition of the hole. The edge condition of the hole may very well impact fatigue life of the repair or retrofit more than the diameter of the hole. Even the quality of the drill bit used can have an effect on the fatigue life. Brown *et al.* (2007) found that holes drilled with dull bits often resulted in fatigue life similar to punched holes, or about Category C. They reference other research which reportedly has shown that these differences can drop the fatigue resistance of the hole to as low as Category D. Figure 4.6 shows an example of the edge conditions following drilling and before sanding. The

cutting process naturally leaves rough edges and burrs that can generate stress concentrations that over time can become initiation sites for fatigue cracks. A recommended sanding procedure includes using an 80 to 100 grit flap wheel with an angle grinder around the outer edges of the hole on both sides of the plate. Then the inside of the hole should be sanded using an 80 to 100 grit flap wheel with a die grinder. The result is a smooth-to-the touch surface free of burrs and rough and gouged edges, while being careful not to burnish the surface, as discussed for painting in Section 4.2. Also, sometimes when drilling begins, the magnetic base may shift as the annular cutter digs into the plate. This can happen when the magnetic connection to the plate is insufficient due to a number of possible reasons, such as excessive moisture, oil, or corrosion, plate curvature, or on very thin plates. When this happens, gouges can result that are capable of initiating cracks over time. This condition can be observed in Figure 4.5 above the third drilled hole from the left. The gouges should be removed using the surface grinding techniques discussed in Section 4.4.

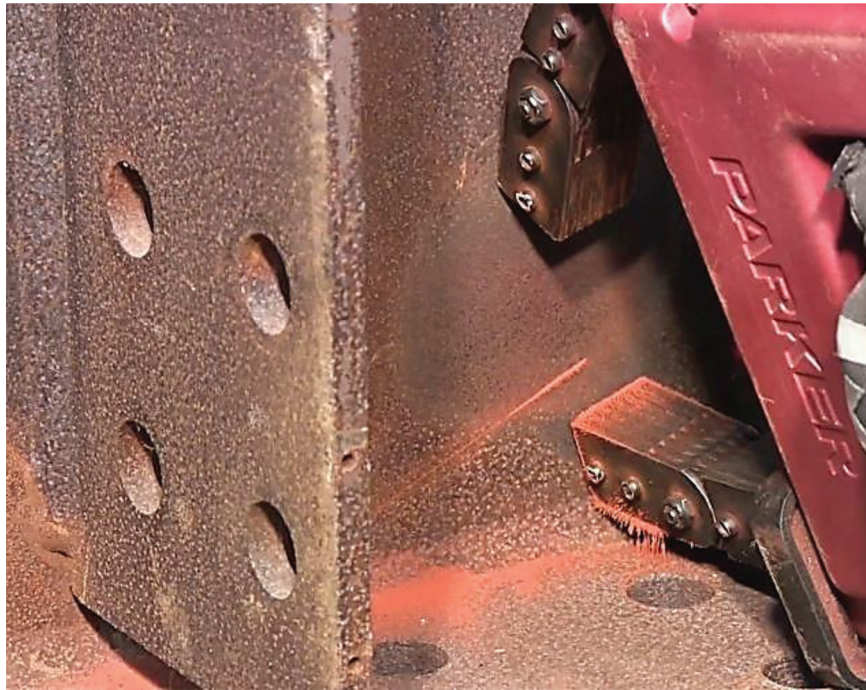
Figure 4.7 Magnetic Particle Test performed before drilling crack arrest hole in order to locate the crack tip.

1. Locate the crack tip using enhanced inspection techniques, such as MT or PT. Figure 4.7 shows a MT inspection being performed where the crack is highlighted by the red magnetic particle dust. Inspect both sides of the plate to ensure the tip is not missed.

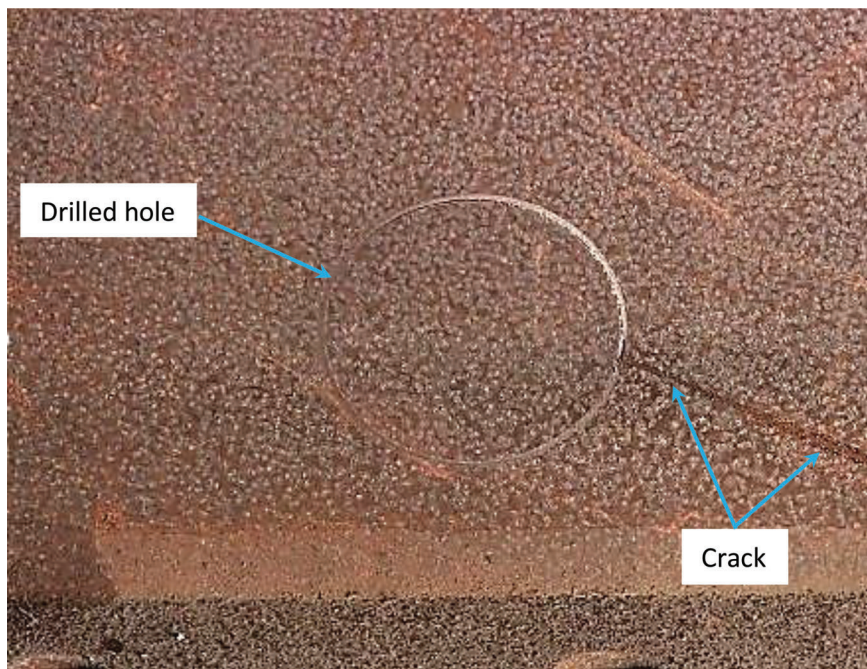
Figure 4.8 Shows annular cutter breaking the surface on the opposite side of the plate, positioned correctly to intercept the crack tip.

4. Check the drilled plate and removed core for evidence of the crack tip, as discussed in Section 4.3.1. Figure 4.8 shows the back side of a plate as the annular cutter breaks the surface. Proper placement of the drilled hole relative to the crack tip is evident.

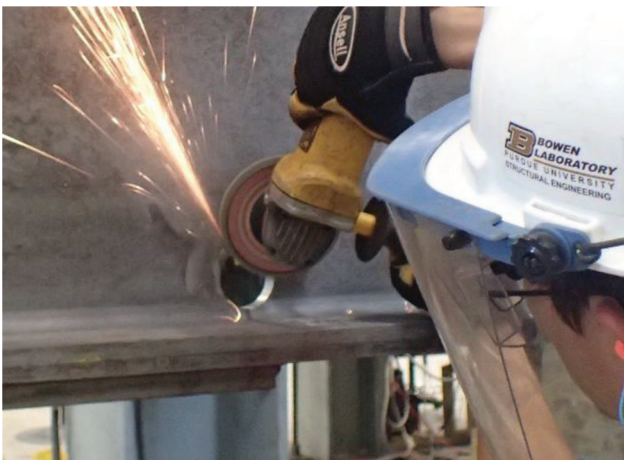
Figure 4.10 Typical angle grinder with flap wheel.

There are two main types of handheld grinders, angle and die. Grinding wheels for the angle grinder typically come in either 4.5 inch or 9 inch diameter and a wide range of types and grits. Also called a disc grinder, the angle grinder can also be used to quickly cut steel when using a cutting wheel. An example of an angle grinder is shown in Figure 4.10 paired with a flap wheel for sanding. A typical die grinder is shown in Figure 4.11 fitted with a rotary burr bit for rough grinding. The die grinder typically uses much smaller abrasive wheels and cutting wheels than the angle grinder, as well as carbide rotary burs, allowing for access to smaller spaces. The angle grinder, although more difficult to get into tight spaces, has the advantage of faster material removal.

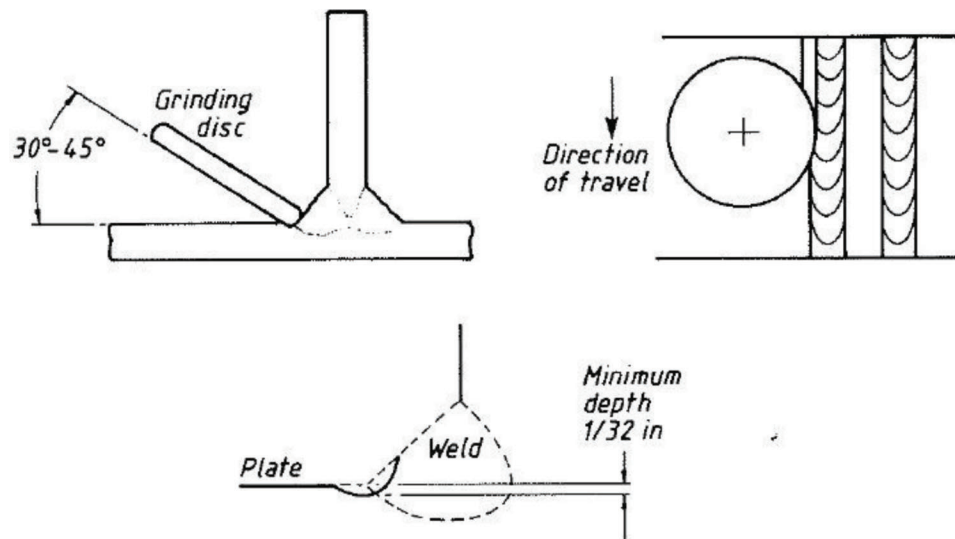
Figure 4.12 Correct tool position for angle grinding of weld toe (Gregory *et al.*, 1989).

2. If using a disc or angle grinder, position the tool as indicated in Figure 4.12.
3. If using a burr or die grinder, position the tool as indicated in Figure 4.13.

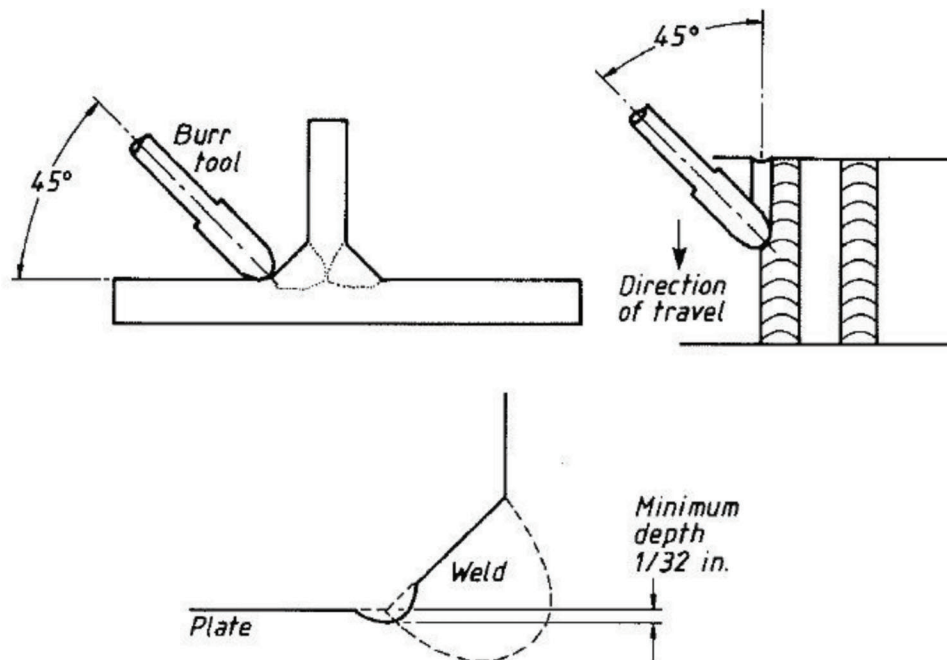
Figure 4.13 Correct tool position for die grinding with burr bit at weld toe (Gregory *et al.*, 1989).

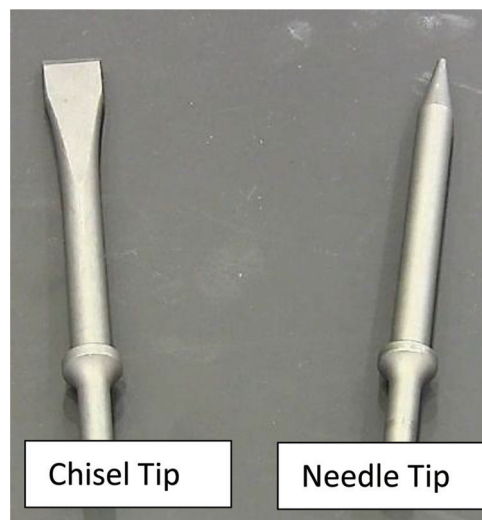
Figure 4.14 Typical peening bits.

- a. Adjust the pressure regulator to 40 psi when using a needle tip. When using a wider chisel-type tip, a higher pressure of up to 60 psi has been found to improve indentation at the weld toe. See Figure 4.14 for examples of a needle and chisel bit.

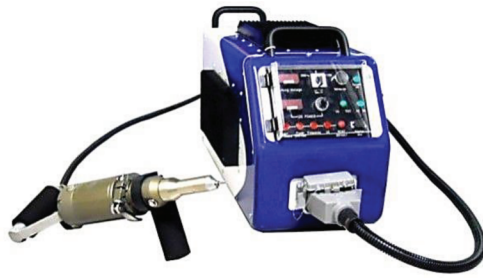
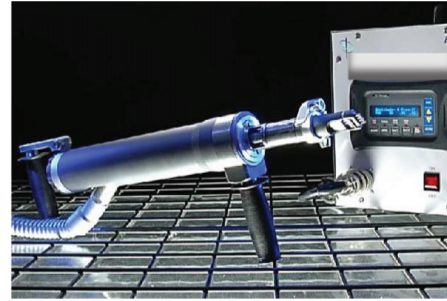
Figure 4.15 Examples of UIT tools.

The primary difference between these two forms of post-weld impact treatment is in the equipment itself. The UIT equipment impacts at extreme rates of 20 to 27 kHz, whereas the peening hammer impacts at only 100 to 200 Hz. The extreme impact rate of UIT affords faster application and minimized areas of missed treatment. UIT is far more precise with computerized, automated controls providing reproducible results. The UIT tools include a handheld tool connected to a generator unit or central unit where controls and monitoring are housed (see Figure 4.15). The equipment is designed to be ergonomic, minimizing vibration discomfort, noise, and worker fatigue for the operator.

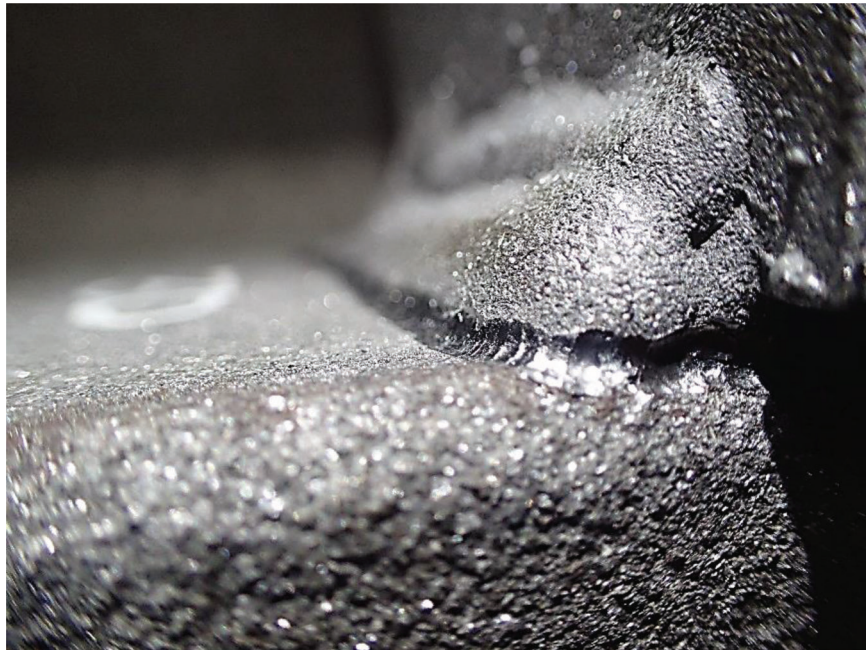
Figure 4.17 Appearance of properly treated weld toe using UNP method.

7. Inspect the groove, looking for uniform, shiny appearance, such as that shown in Figure 4.17. A 3/32 welding rod or a peening needle can also be lightly dragged through the groove. A well-formed groove will allow the rod/needle to slide without catching. If gaps in treatment are located, repeat treatment in those areas and inspect again.

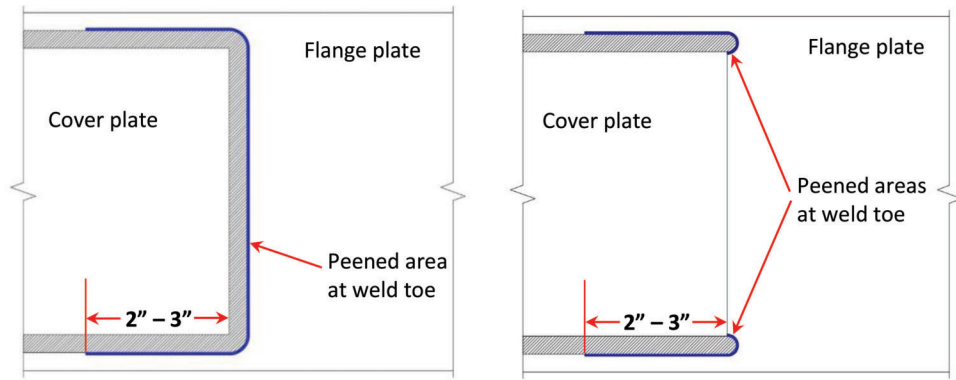
Figure 4.18 Recommended peening locations for cover plate details with (Left) and without (Right) the transverse weld.

Figure 4.18 is provided as a sample retrofit for a cover plate weld termination showing the areas recommended for peening with the bold blue lines. This detail would be categorized as E' or E, depending on the thickness of the cover plate. Notice that the peening is only performed at the termination of the cover plate welds, following the weld toe around the corner of the cover plate, and extending 2 to 3 inches back from the termination. The longitudinal weld that runs parallel to the plate is a category B fatigue detail and would not be expected to crack under typical live load stress ranges. UIT applications generally should focus around details with low fatigue resistance, such as E' or E, but can be used on most any weld to improve fatigue resistance. Applying UIT, and peening treatments in general, in this way will save significant cost.

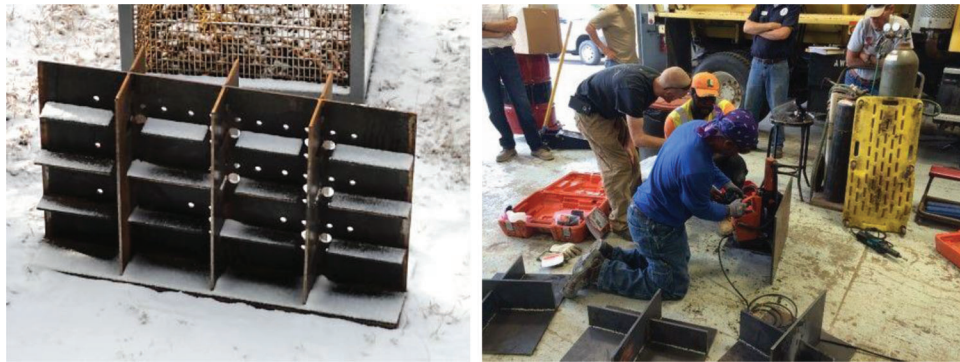
Figure 4.19 (Left) Example of used mockup, (Right) Performance testing of a contractor prior to implementation of a repair project.

Experience has shown that even the most experienced contractors and maintenance crews can underestimate the challenges of executing repairs on steel bridges. Unfortunately, in some cases it is not until they actually begin work that those challenges surface. This type of situation can cause costly delays for the owner and the contractor, or worse, actually cause damage to the structure. Figure 4.19 shows an example of a used mockup specimen (left) and ironworkers performing

repairs as part of a performance test (right). This type of testing can be successfully included in rehabilitation contracts where the scope of work requires the fabrication of mockups and satisfactory completion of the test before work can begin on the bridge. The performance test provides two primary functions, (1) to ensure the work can be completed as intended by the contractor, and (2) to establish the level of quality that is expected on the project to all parties. Typically, mockups can be fabricated for only a few thousand dollars, depending on the complexity of the detail. The fidelity of the mockup to the actual detail is very important. Size, quality, condition, and geometry should be replicated as much as possible. Economy is achieved by duplicating the detail like shown in Figure 4.19, without compromising authenticity. Difficult-to-access areas, such as corners of intersecting plates and connection elements should not be overlooked because often it is these details that make the actual repair or retrofit challenging and where the real benefit of the mockup will be gained.

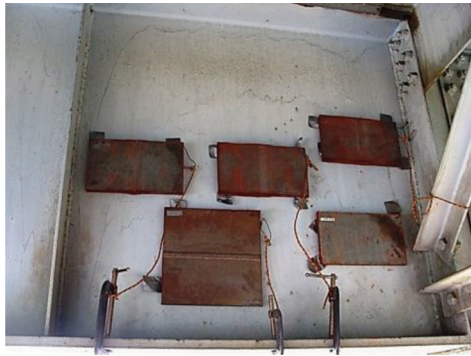
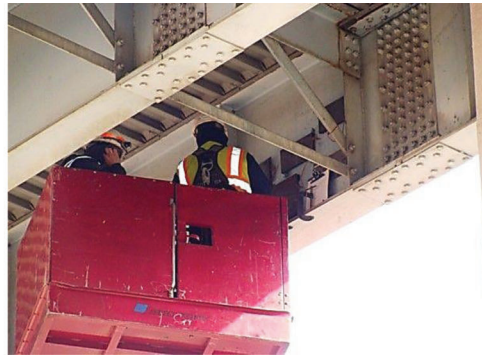
Figure 4.20 (Left) Welded steel test specimen hung on a bridge, (Right) Performance testing of an inspector prior to beginning NDT on bridge welds.

results has been shown to occur among certified inspectors where variances in thoroughness, care with which NDT procedures are followed, and interpretation of results differed. Washer *et al.* (2014) conducted performance testing of ASNT Level II and III certified UT and MT inspectors to establish inspector qualifications prior to inspection work beginning on the Sherman-Minton Bridge over the Ohio River near Louisville, KY. Before inspecting the tied arch structure, inspectors were first evaluated in a performance test program. The welded-steel specimens used for performance testing were fabricated plates with known flaws of various sizes. Figure 4.20 shows similar test specimens hung on a bridge (left) and an inspector completing a performance test (right).

Installing the test specimens on the bridge helps to make the test authentic, ensuring ambient factors present in actual inspection are also at play during testing (i.e., wind, temperature, access, bucket sway, lighting, etc.). A sample of the test results is provided in Figure 4.21 (Washer *et al.*, 2014). The horizontal axis is the actual flaw length and the vertical axis is the measured flaw length as reported by each inspector. The diagonal line passing through the plot represents the correct flaw length and the solid circles are the average measured lengths. The results of the performance tests identified inspectors whose performance was substandard and provided quantitative measures of

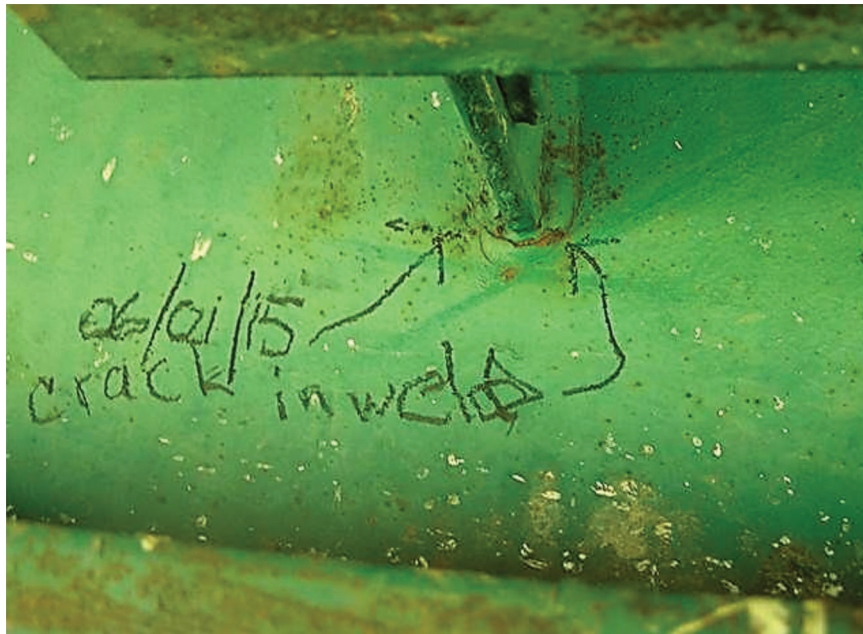
Figure 4.22 Distortion-induced fatigue crack growing out of the throat of the weld.

A simple “two-hole” retrofit for distortion-induced fatigue cracking on twin, 6-girder interstate bridges was evaluated using a prototype. The superstructure of the bridge included 30 skewed spans made up of six 48 inch deep, continuous plate girders with a fully composite reinforced concrete deck. Bridge inspectors discovered distortion-induced fatigue cracks that initiated at the bottom of several transverse connection plates and grew into the web plates. This prompted a more thorough arms-length inspection of the bridge resulting in 30 locations identified with fatigue cracks grown into the web plate and hundreds more locations that appeared to have some distortion-induced cracking at the weld termination (as seen in Figure 4.22) that had not yet grown out into the web plate. The unique aspect about this distortion-induced fatigue cracking was that it was occurring despite the relatively large 5 inch web gap, which can also be seen in Figure 4.22. Most often distortion-induced cracking occurs where there are much smaller web gaps, however, larger web gaps can also crack if sufficient displacement occurs and particularly when weld quality is lacking.

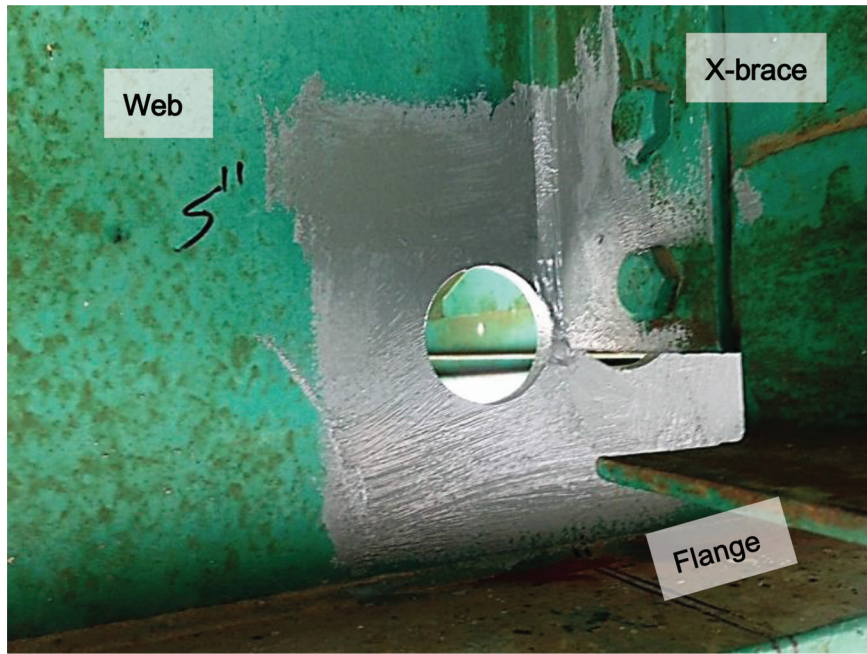
Figure 4.23 Example of prototype “two-hole” retrofit installed.

a few locations were identified to install a prototype. One example of the prototype can be seen in Figure 4.23. A 3 inch diameter hole was drilled on each side of the connection plate, surrounding the weld termination and isolating it against web crack propagation. Following installation of the prototype, the areas were instrumented, along with a couple benchmark locations where no repairs were made. Field monitoring of live load stresses in the primary members, in the web gap

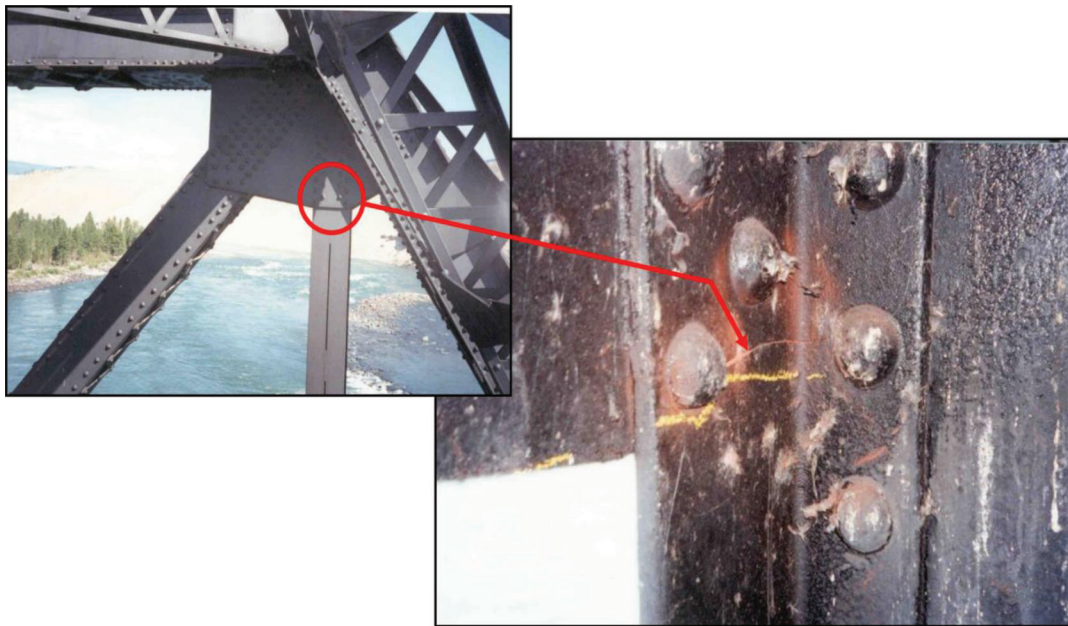
Figure 5.1 Example of load-induced fatigue crack located on a railroad through-truss hanger.

Load-induced fatigue is caused by the in-plane stresses in the primary structural members that make up the structure cross section. Load-induced fatigue stresses are directly correlated to the live load stresses that can be calculated using conventional axial and bending analysis at the location of the detail in question, or nominal stresses. This approach is valid because of the way the fatigue categories were initially developed by correlating large-scale fatigue test results with the nominal stress ranges. The detail category itself implies inclusion of the characteristic stress concentrations, residual stresses, and defect distribution inherent in that detail or group of details. An example of load-induced fatigue cracking is shown in Figure 5.1. This example shows a fatigue crack that has grown from the first rivet hole on a railroad truss hanger. This is a relatively common location for fatigue cracks to occur.

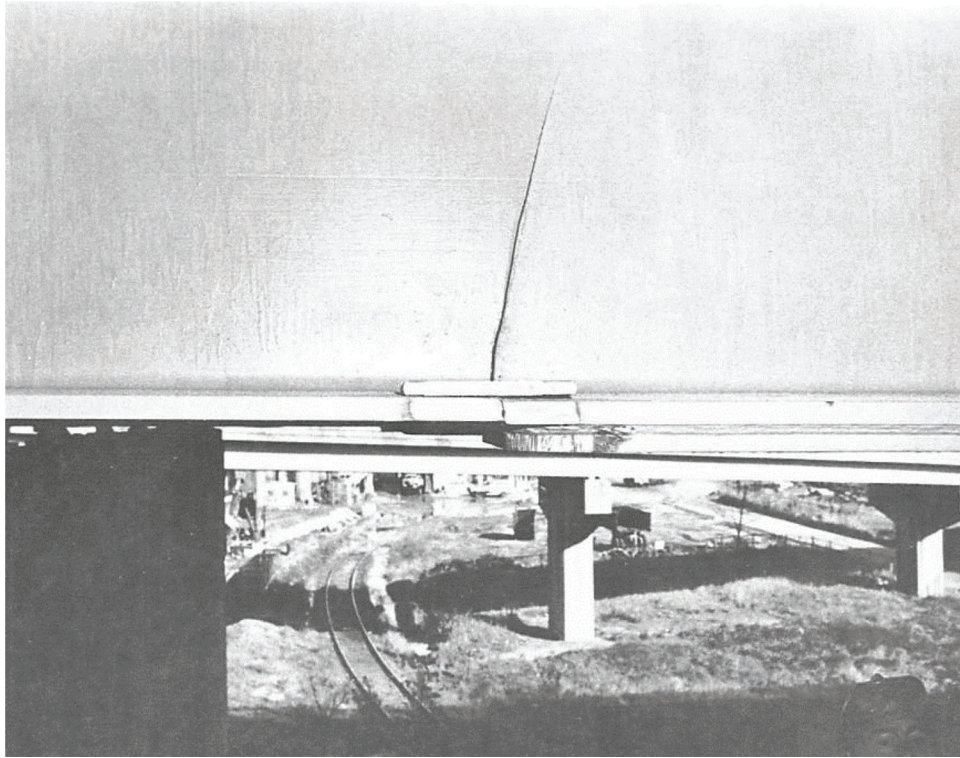
Figure 5.2 16 inch long fracture resulting from fatigue crack at cover plate weld toe (Bowers, 1973).

Fatigue cracks have been known to form in the weld toes of cover plate terminations since the 1960s when several such details cracked as part of the AASHTO Road Test. Relatively large stress ranges (~ 12 ksi) under controlled truck traffic developed fatigue cracks on multiple-beam bridges (Fisher, 1984). In 1970 a cover plate termination fatigue crack located on the Yellow Mill Pond Bridge in Bridgeport, Connecticut, resulted in the partial fracture of an internal cover plated beam (Bowers, 1973). Figure 5.2 shows an elevation view of the resulting fracture, which reached 16 inches into the web plate before it arrested and was later repaired. Subsequent inspections of other cover plated beams along I-95, prompted by the discovery of the crack on the Yellow Mill Pond Bridge, revealed many other small (less than 1 inch) fatigue cracks in cover plate weld toes (Bowers, 1973). These details, as well as that shown in Figure 5.2, were repaired with bolted splices or treated with hammer peening.

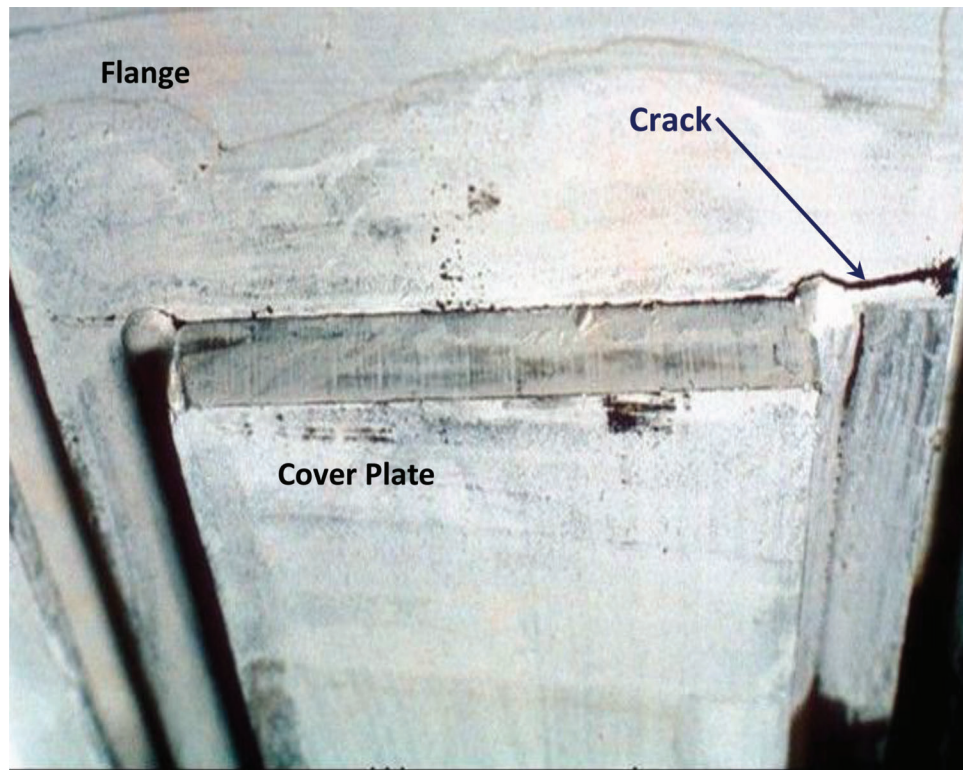
Figure 5.3 Example of cover plate fatigue crack at detail without transverse weld (Fisher *et al.*, 1979).

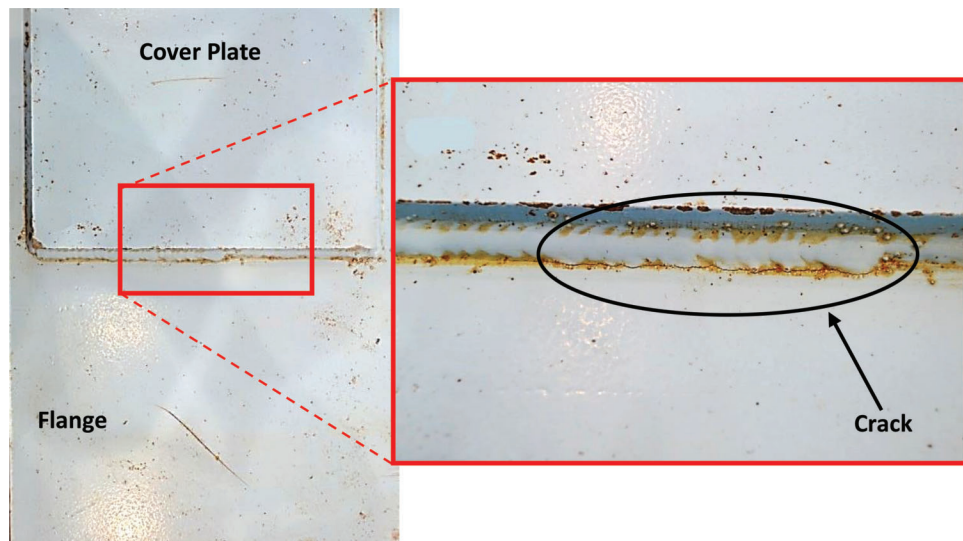
Figure 5.4 Example of fatigue crack at a cover plate with transverse weld.

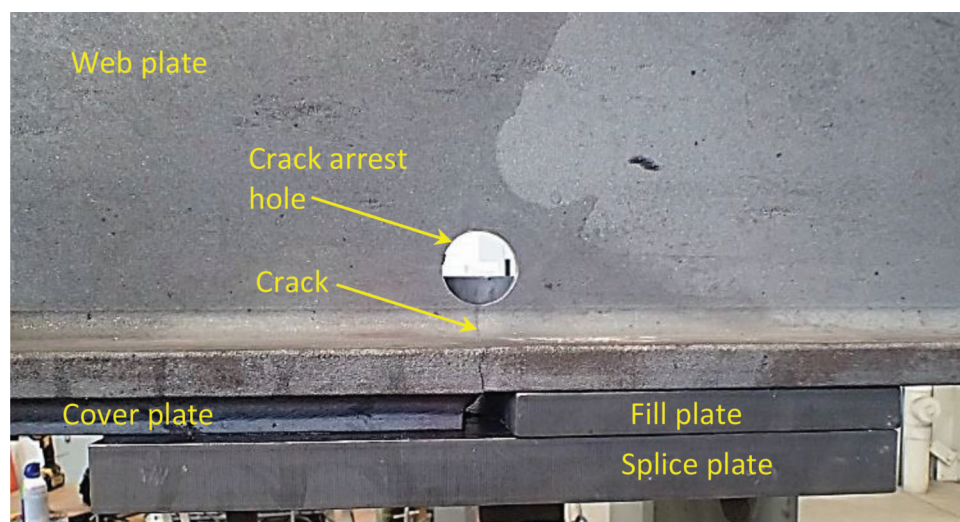
Figure 5.5 Crack arrest hole preventing crack from propagating into the web plate.

(Hassan & Bowman, 1995). See Section 4.2 for hole drilling techniques. Adding a 2 to 4 inch diameter drilled hole in the web directly above (or below in cases where the cover plate is on a top flange) the cover plate weld toe could also be done to ensure that any future crack growth cannot extend into the web plate. An example of this is shown in Figure 5.5 showing a fatigue crack that has grown through the thickness of the flange plate and is arrested in the drilled hole. Figure 5.6 renders what a typical full bolted flange splice over the cover plate termination might look like.

4. Drill a 2 to 4 inch diameter hole through the web plate directly above (or below in cases where the cover plate is on a top flange) the cover plate weld toe, as shown in Figure 5.5 to prevent further crack propagation. Refer to Section 4.4 for drilling techniques and hole edge finishing.

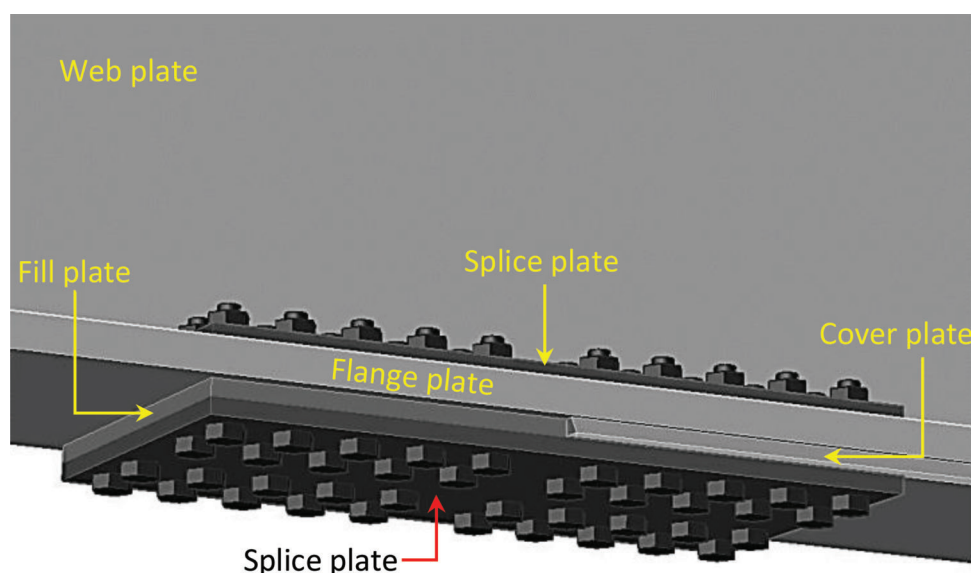
Figure 5.6 Rendering of full flange splice at cover plate detail.
